MASS WASTING SUMMARY TOLT RIVER WATERSHED ANALYSIS

TOLT RIVER WATERSHED ANALYSIS METHODS AND COMMENTS

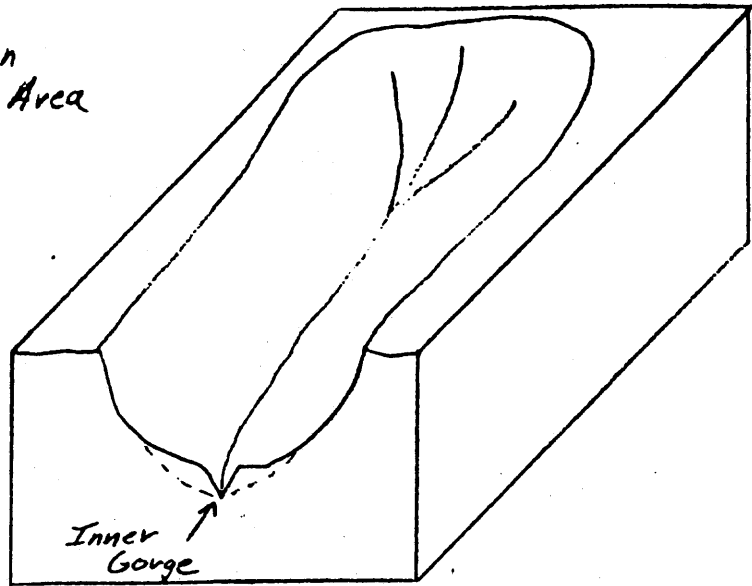
Figure 1. - Inner Gorge in Alpine Glaciated Area

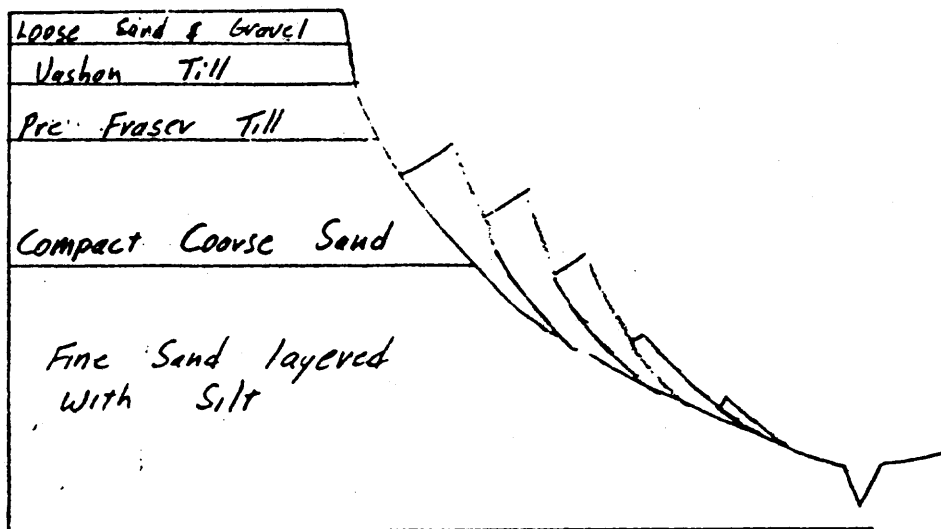
Figure 2. - Ancient Slump in QPF

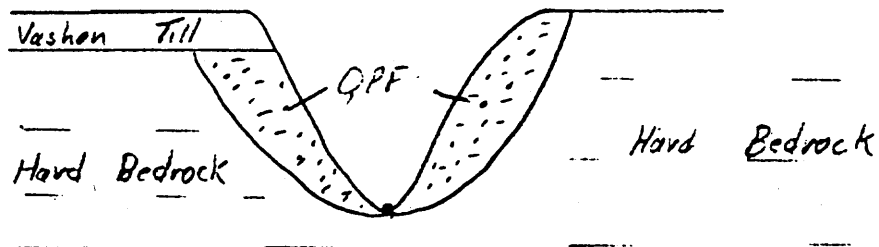
Figure 3 - Inner Gorge in QPF
